# Co-Extrusion of Zr Lined U-Zr Alloy Characterization Report

**Nuclear Technology Research and Development**

NTRD-FUEL-2018-000081

This report details the characterization of a recent feasibility test to determine if uranium-10wt% zirconium (U-10Zr) and uranium-6wt% zirconium (U-6Zr) can be successfully co-extruded with a zirconium liner or can. Both U-10Zr and U-6Zr billets were cast and seal welded into a close fitting zirconium can. After canning the billets both were extruded and characterized. Characterization included radiographic examination, dimensional inspection, and metallography of radial and longitudinal samples along the length of the extrusion. A third U-10Zr billet was cast directly into the zirconium can; however, this billet has not yet been extruded.

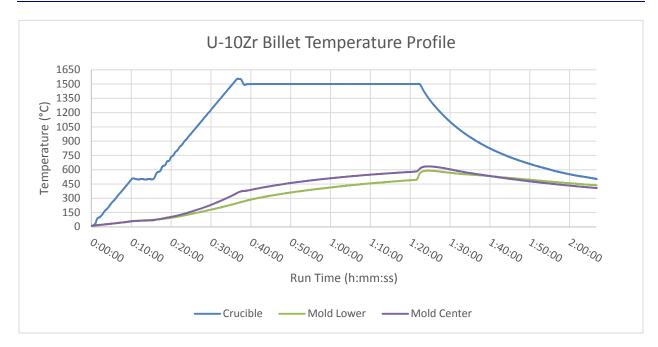
Figure 2. Typical heating profile for the U-Zr billets.

differences in compositions, both billets were cast using the same heating profile as shown in Figure 2. The crucible was heated and held at 1500°C for approximately 43 minutes to allow the zirconium to fully dissolve and the molten material was then poured into the mold. After casting, the billets were machined to the appropriate length for extrusion and the diameter was reduced to allow a slip fit into the zirconium can with minimum clearance. The billet sketch in Figure 3 shows the nominal dimensions of the billet. It should be noted that no attempt has been made to optimize the casting process to reduce the amount of scrap material made. After machining and test fitting to final dimensions the billets were loaded and seal welded in the zirconium cans. Sealing was done in a purified argon atmosphere glovebox using standard gas tungsten arc welding techniques. After welding the billets were ready for the extrusion process.

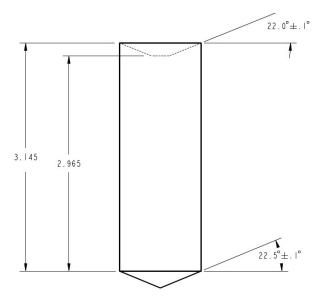
Figure 3. Sketch of the final machined billet ready for canning. As with Figure 1 the footer or trailing end is down on the sketch. Dimensions are in inches.

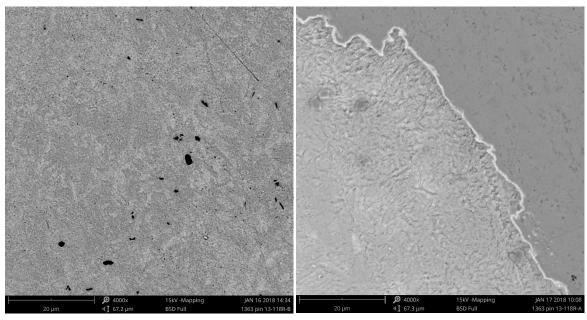
Figure 8. Typical interior microstructure consisting of  $\alpha$  (lighter) phase,  $\delta$  (darker) phase, and zirconium precipitates (black phase).

Longitudinal and radial sections were examined from the center portion of the U-6Zr rod. Examination of the radial section showed a microstructure similar to what was expected. Liner thickness was estimated to be between  $500~\mu m - 600~\mu m$ , because of the high surface roughness exact measurements made at various locations varied within this range. The microstructure was a typical 3 phase microstructure composed of fine distributions of  $\alpha$ -uranium and  $\delta$ -UZr<sub>2</sub>, and larger high zirconium precipitates throughout the structure. Figure 8 shows a typical radial micrograph. Also observed was a microstructural gradient from the Zr liner to the interior of the rod. Figure 9 shows an example of this. The liner and bulk fuel appear to be bonded with a small amount of porosity being visible on the interface line. However, also notable is the noticeably courser microstructure next to the liner. Energy dispersive x-ray spectroscopy (EDS) scans revealed that the area of courser microstructure was several percent high higher in zirconium than the interior. EDS data shows that the gradient does not appear to be uniform, with decreasing uniformly towards the center of the fuel, but rather appears to have a more abrupt drop in zirconium content, as it moves away from the liner. The longitudinal center sample showed very similar microstructure, as seen in Figure 10-11.

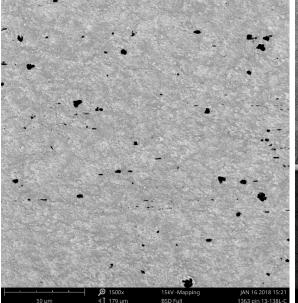
Figure 9. Edge microstructure showing courser phase near the Zr liner progressing to a finer microstructure.

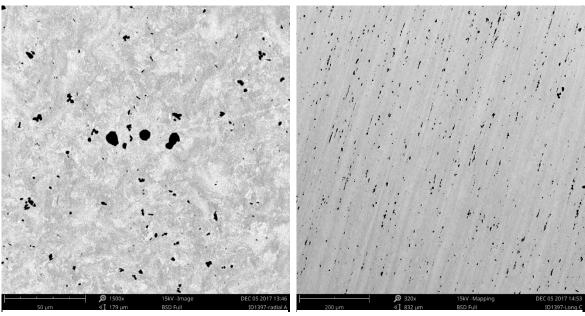
Figure 15. Radial section from the center portion of the U-10Zr rod.

Extrusion of the U-10Zr rod went as planned and was very similar to the U-6Zr extrusion. As seen in Table 4 the average diameter of the U-10Zr rod was slightly smaller than that of the U-6Zr. The Zr liner was also slightly thinner. As with the U-6Zr rod, a consistent Zr thickness measurement was not possible because of the roughness of the extruded product. However, based on estimates made from metallographic images, the Zr liner thickness is slightly less (approximately 50  $\mu$ m) than the Zr liner present on the U-6Zr rod. The central section microstructure was similar to the U-6Zr, a mixture of  $\alpha$ -uranium,  $\delta$  UZr<sub>2</sub>, and Zr precipitates. This is also typical of what is seen in U-10Zr fuels, as shown in Figures 15. Based on optical microscopy a grain size of approximately 20  $\mu$ m or less can be visually estimated. Different from the U-6Zr rod, however, the longitudinal view shows a deformed microstructure with well aligned zirconium precipitates, shown in Figure 16.

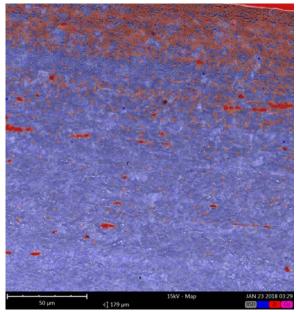
Figure 17- Left) X-ray map showing increased Zr content on the outside of the fuel.
Figure 18-Above) Leading edge showing zirconium interior to the fuel and well as outside.

Similar to the U-6Zr extrusion a zirconium and microstructure gradient can be seen along the length of the fuel with a lower zirconium content towards the inside of the fuel. EDS analysis showed this gradient to be slightly greater than the gradient seen in the U-6Zr fuel. Figure 17 shows an x-ray map near the outside edge on the trailing end of the rod which illustrates the gradient well. Unlike the U-6Zr fuel the trailing end of the U-10Zr ended abruptly. This can be seen in Figure 7, as well as metallographic analysis. Samples taken from the trailing end were very similar to those taken from the center of the fuel but the leading end was different. Although the fuel did not appear as tapered, a small taper was still visible. The start of the fuel zone appeared with a blunted end. On the very end of the fuel a decrease in density can be detected on the radiograph. This length was sectioned and showed some zirconium flowed into the interior of the rod before the fuel reached a steady state flow. Figure 18 shows a radial cut section with zirconium present in the center and on the outside surfaces. As with the U-6Zr extrusion the steady state flow was reached with 100 mm or less.

Both U-6Zr and U-10Zr showed a zirconium gradient from higher zirconium content on the outside edge and lower zirconium content in the center. From initial characterization, the gradient does not appear to be a uniform decrease through the thickness. Figure 17 shows a more abrupt drop from the higher content to lower. It should be noted however, that this gradient has not been fully characterized yet. The cause of the gradient is under investigation. It is possible that the hot extrusion process enhances diffusion from the zirconium can to the interior, however, the assembly is only heated for approximately 30 minutes and the extrusion is performed quickly, and then is cooled. Another possible cause of the gradient is zirconium segregation in the starting billet. This possibility is also being investigated by performing metallography on the initial billet; however, this is still in progress.

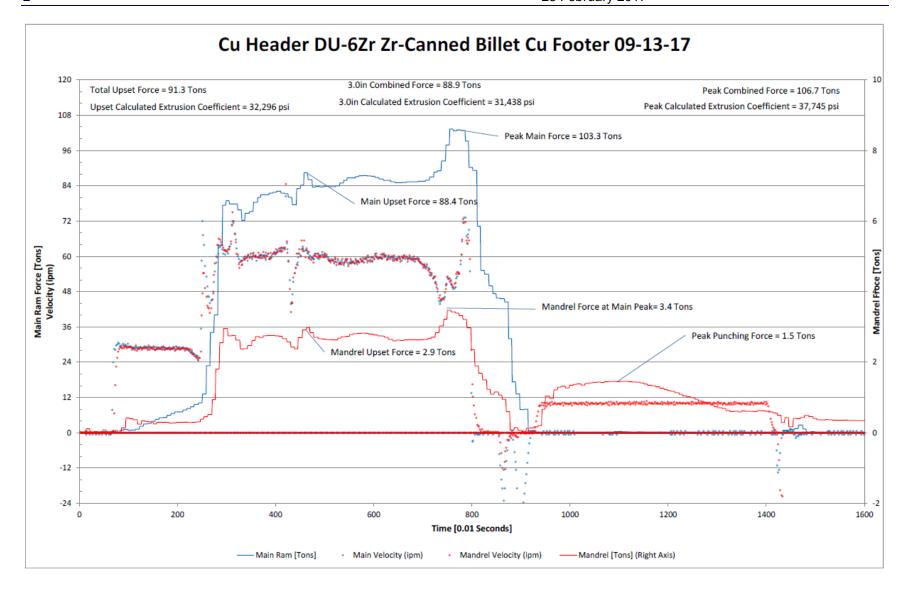
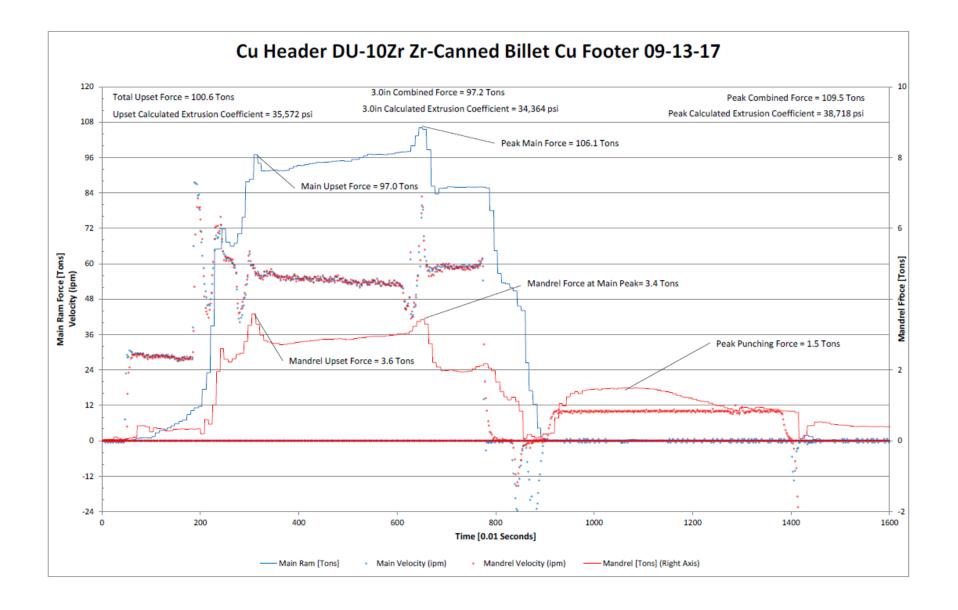
## **Force and Velocity Data**

Table 3 shows total upset force, the upset force at approximately 3 inches along the billet extrusion, and the peak force as well as the corresponding extrusion coefficient seen during the extrusion for each billet. Appendix I contains the annotated force and velocity profile for each extrusion.
